G481 – THE HERMINGTON @ KUCHAI LAMA

Project Introduction

The Hermington is a prestigious project by Aset Kayamas, comprising of 479 residential units and located just a short distance from downtown Kuala Lumpur. To be more precise, the project site is situated on sloping terrain adjacent to NPE Highway, in which the topographical ground level varies from 74mRL to 29mRL.

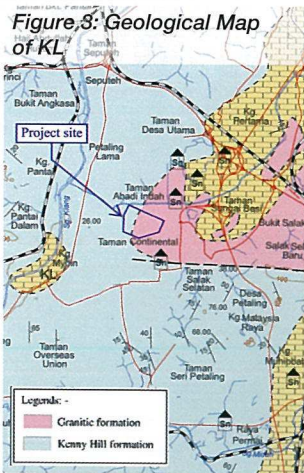
As revealed from the available soil investigation (SI) information, the project site is underlain by both granitic formation and Kenny Hill formation as shown in Figure 3. These substantially different geological formations were verified from exploratory boreholes (Figure 4), which demarcates the site into two (2) geological zones.

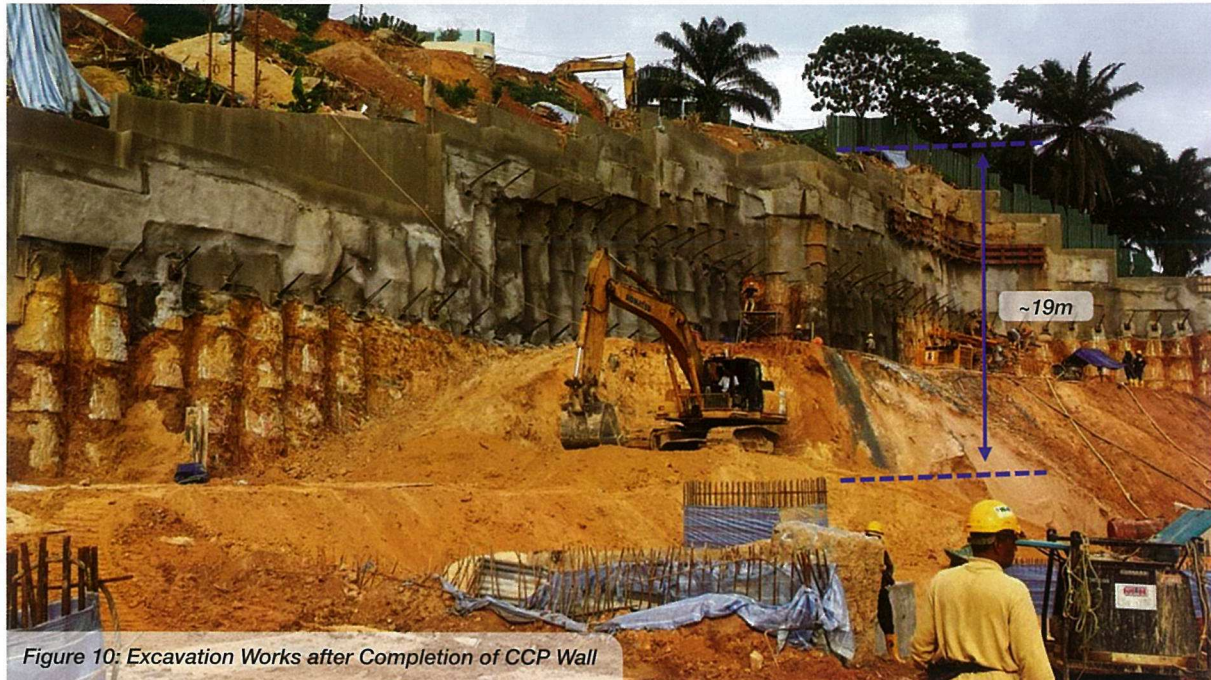
Figure 10: Excavation Works after Completion of CCP Wall

As highlighted earlier, the original CBP wall at Section 1 was converted to CCP wall due to steep hilly terrain where platform preparation for heavy boring machine may entail massive earthwork and associated possible safety or slope stability issues. As consequence, the construction period for the embedded wall is prolonged and subsequently affecting the bored pile works in Section 1, which can only be commenced after cutting the platform to the design level (~19m high) upon completion of CCP wall and two (2) levels of temporary ground anchor (Figure 10).
