# PROJECT WRITE-UP

## G472-WJ2 PV RMM 1 @ KG WIRAJAYA

### Project Introduction

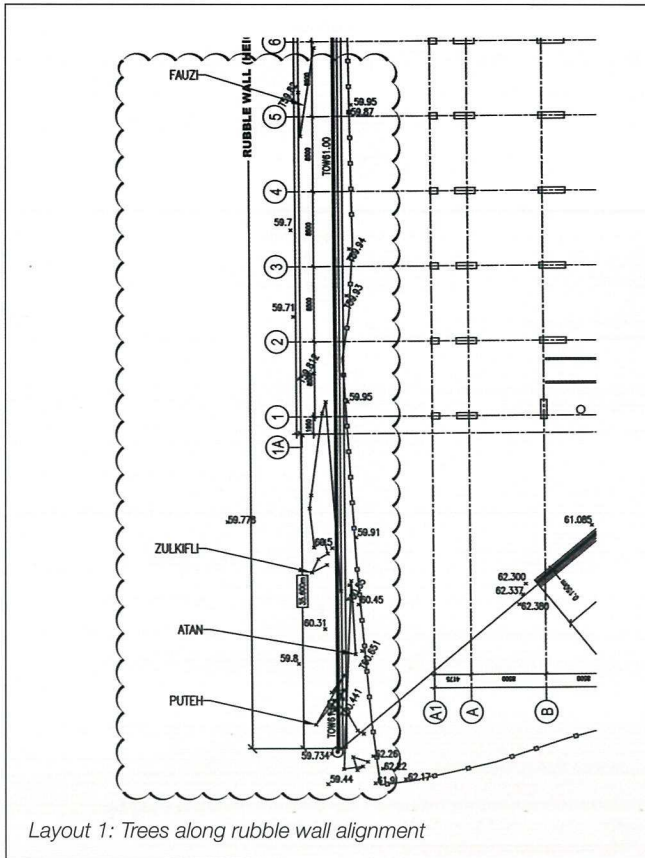
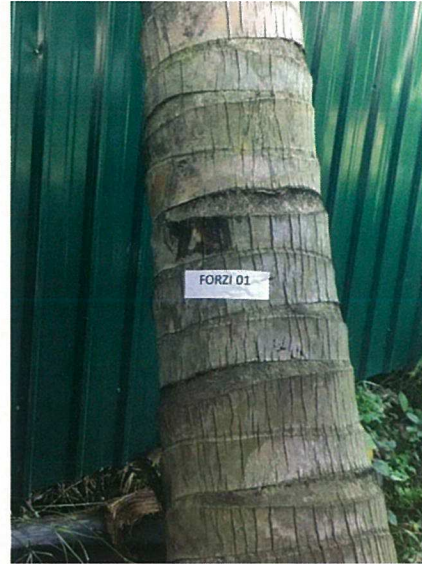
Figure 3: Trees on rubble wall alignment

In the case between the resident and our construction site, trees totalling of 28 nos on Ambanang' property had to be completely removed because the trees unduly obstructed the future development of rubble wall. The trees were to be removed and the cost of doing so paid by the developer.
