Concerto North Kiara @Mont Kiara

The Proposed Jack-in Square Pile to Speed Up the Work Progress

(by Ir. Oh Chin Wah, Executive Director) (2012 Oct-Dec)

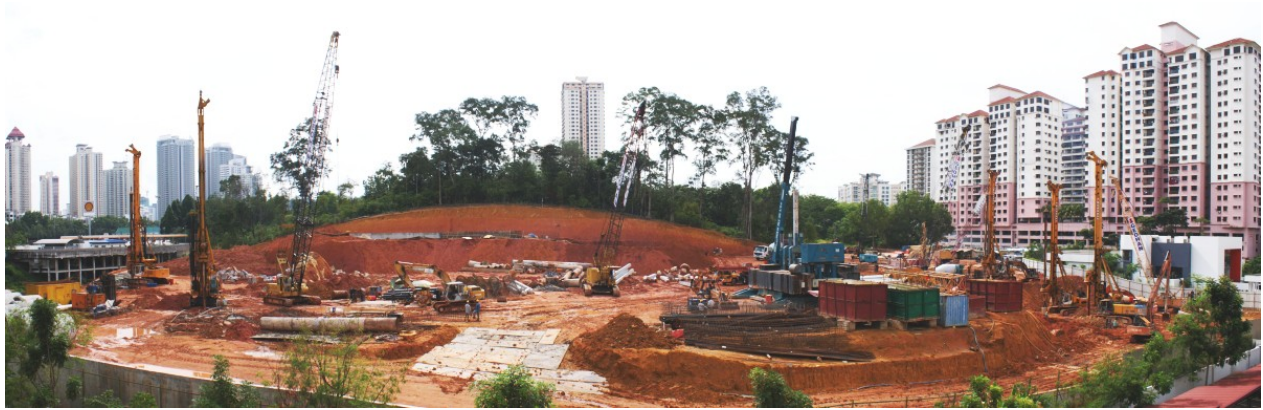
Construction Site

This development consists of 3 block high rise condominium of 30 to 32 stories with 4 level of car park and 1 level of basement floor for M&E services. The project is awarded as a contractor design and build contract for foundation package which comprises various sizes of bored pile ranging from 500mm to 1350mm diameter with higher concrete grade of G40 N/mm². Total number of bored piles is 389 and the construction duration for this project is 7 months. The entire site is divided into 4 zones in according to the estimated pile length based on the SI borehole results.

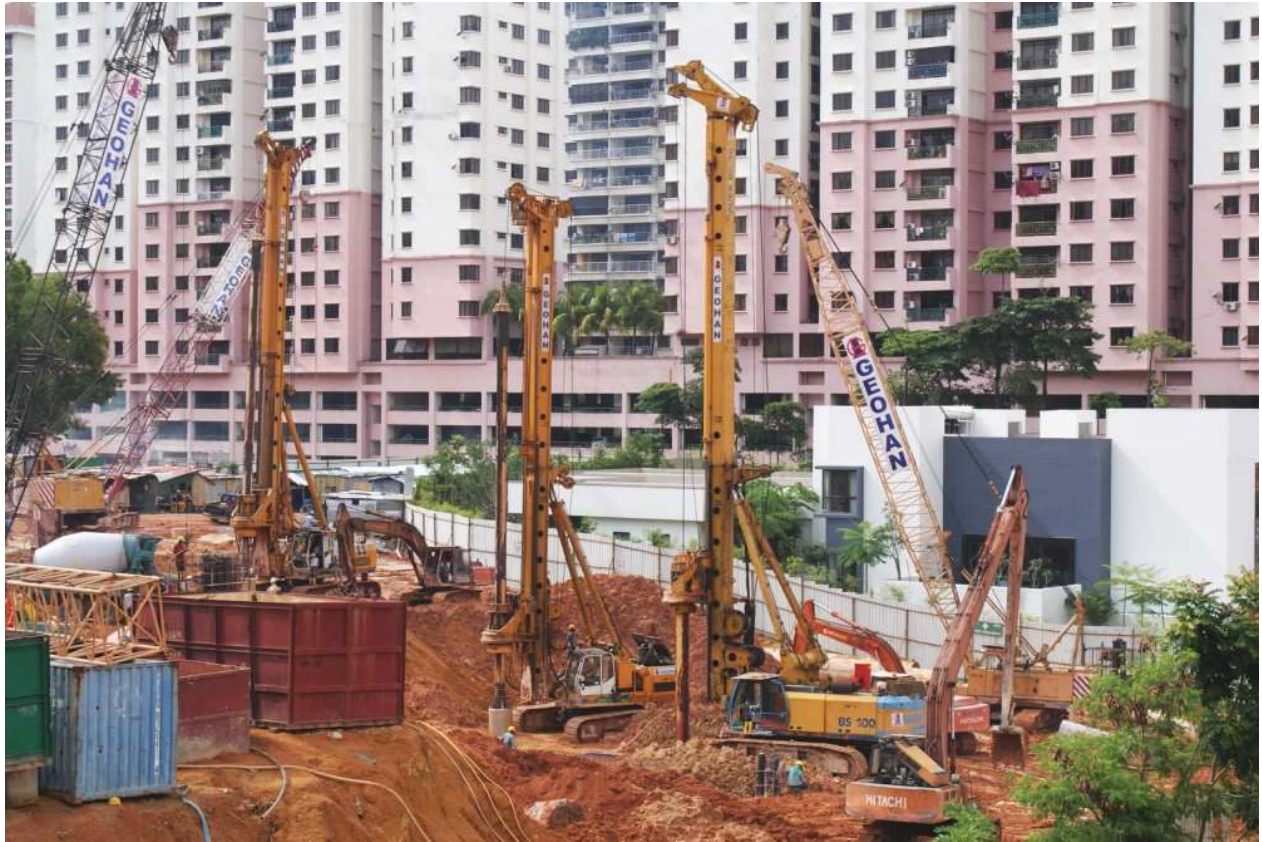
Construction Site

However, a great surprise was encountered during the earthwork excavation at zone 1 area. A group of fresh granite boulders (site people named it as " dinosaur eggs")with size ranges from less than 1m up to even 3m was unearthed and the level is well above the final piling platform level. Eventually, it took us nearly 2 months to break this group of boulders into

pieces that able to transport out from the site. Nevertheless, this was just the beginning of the nightmare for boredpiler when they first encountered this boulder problem at site.
